NASA Contractor Report CR-195395

# Two Rotor Stratified Charge Rotary Engine (SCRE) Engine System Technology Evaluation

**T. Hoffman, J. Mack and R. Mount**  
*Rotary Power International, Inc.*  
*Wood-Ridge, New Jersey*

Prepared for  
Lewis Research Center  
Under Contract NAS3-26920

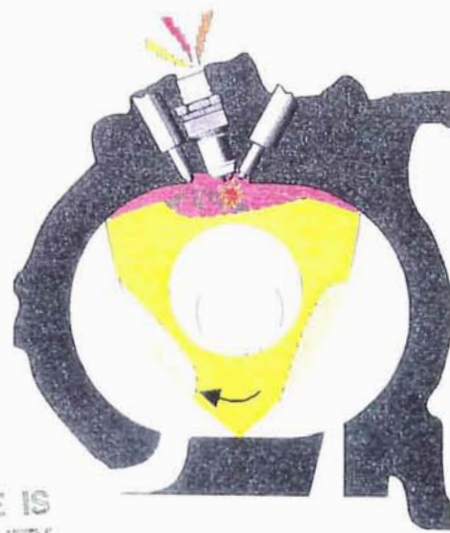
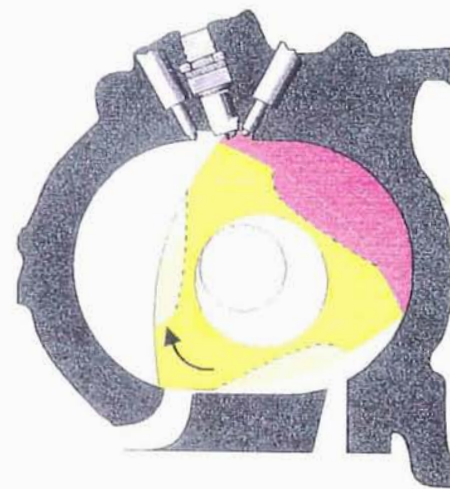
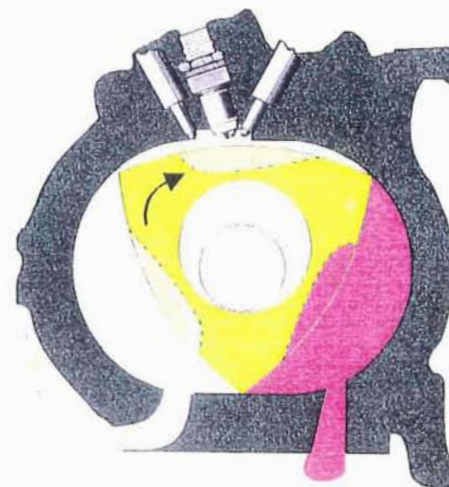
# Direct Injected Stratified Charge Combustion Cycle

Note: Events shown for one flank only for clarity. Other two flanks follow same cycle.

INTAKE

COMPRESSION

IGNITION

EXPANSION

EXHAUST
